TECHNICAL DOCUMENT TO SUPPORT
NO FURTHER ACTION DECISION
FOR SITE SS17-BUILDING 102

KOTZEBUE LONG RANGE
RADAR STATION, ALASKA

JULY 1995

PREPARED BY:
TETRA TECH INC.
15400 NE 90TH, SUITE 100
REDMOND, WA 98052

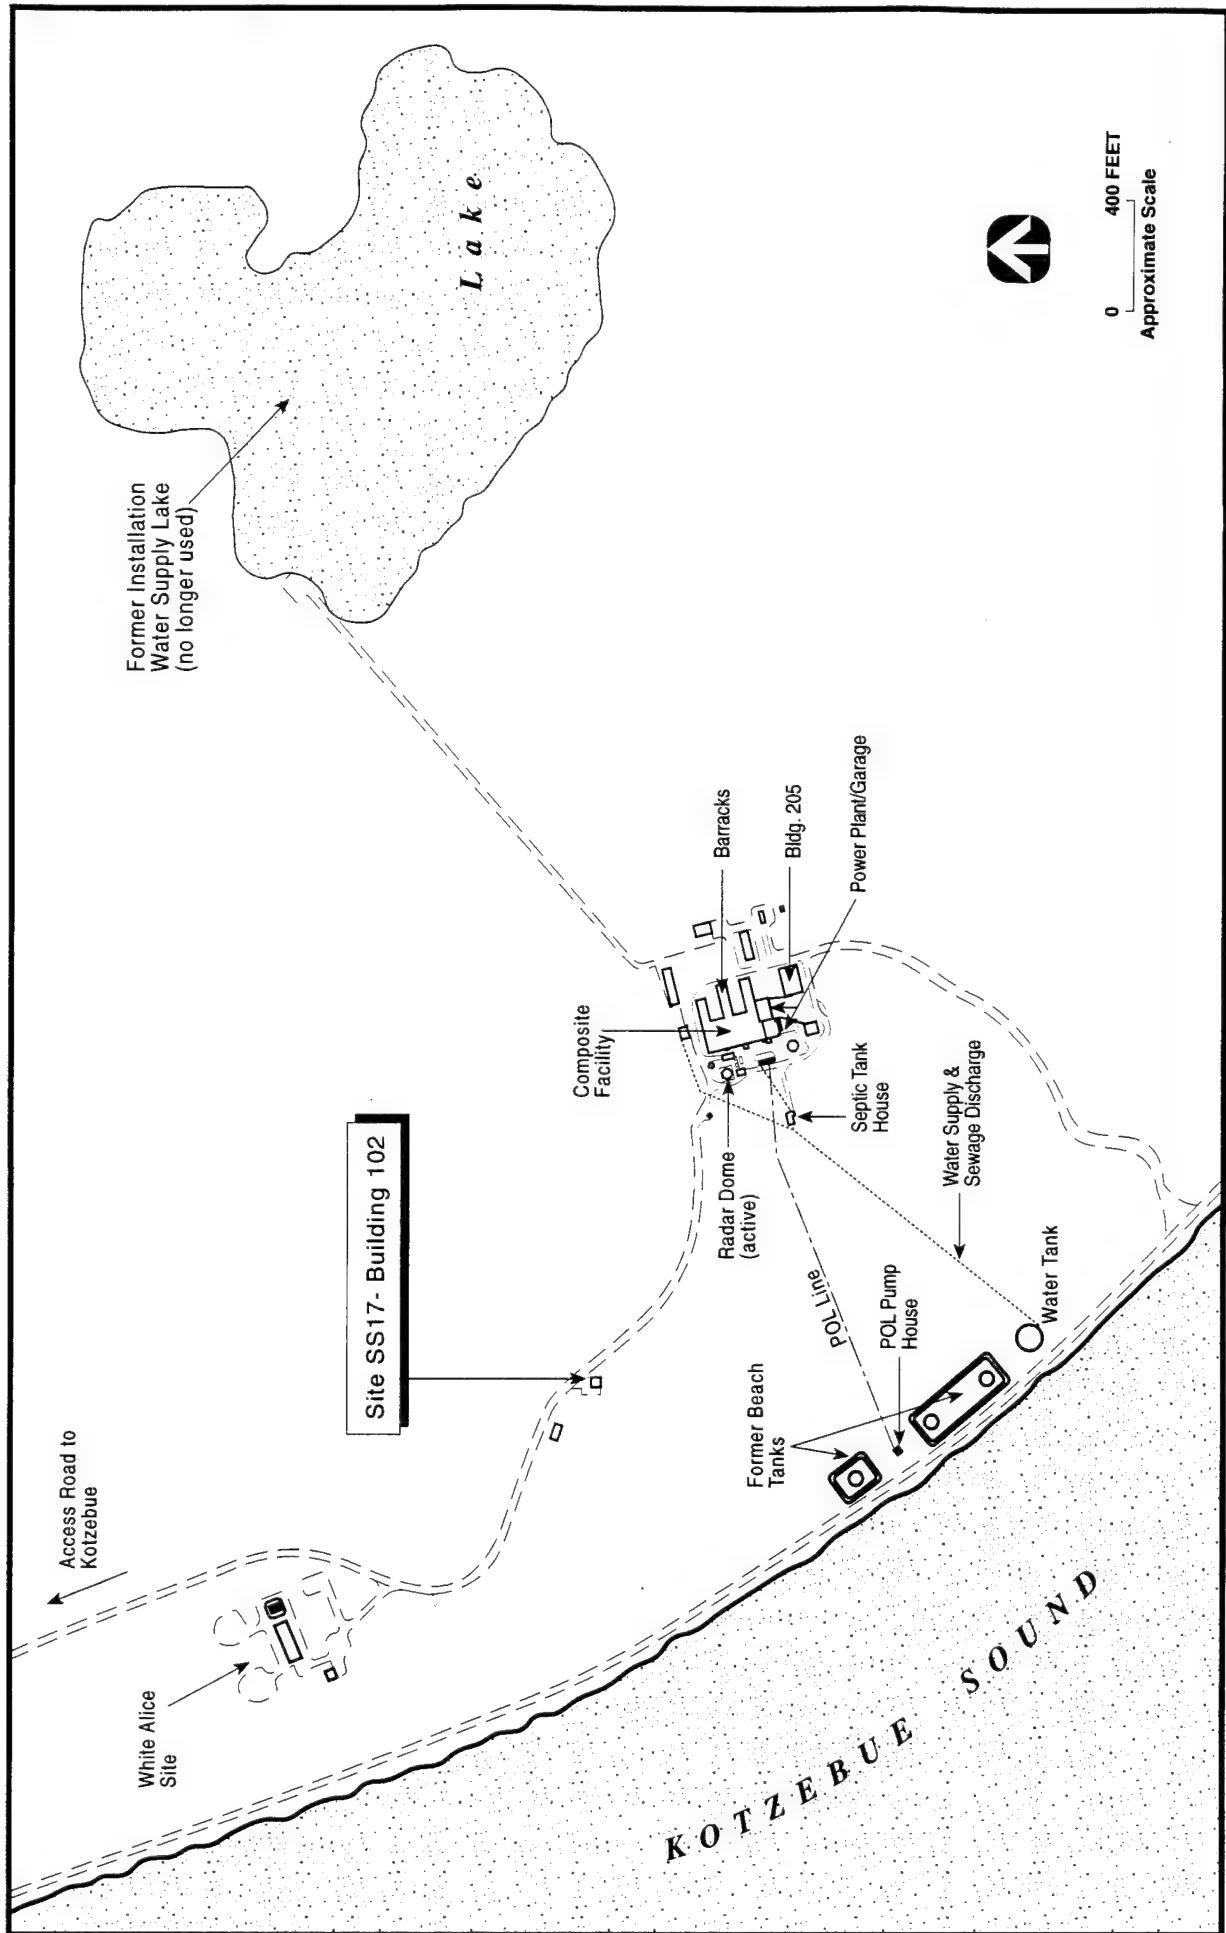
Figure 6. Location of Site SS17-Building 102, Kotzebue LRRS, Alaska.

Site SS17 is an area of stained soil approximately 6 feet by 12 feet, located in a gravel driveway at the Navigational Aid Building No. 102 (Figure 6). The area of stained soils extends from the gravel drive entrance to the edge of the facility access road. This site is incorporated in the characterization of Site SS16-Navigational Aid Buildings.

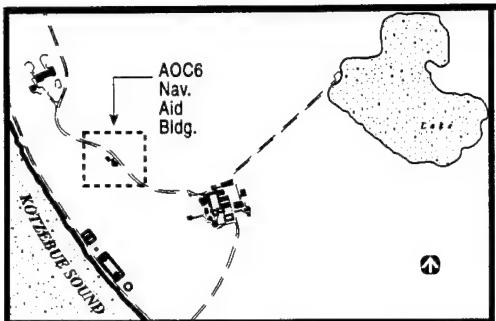
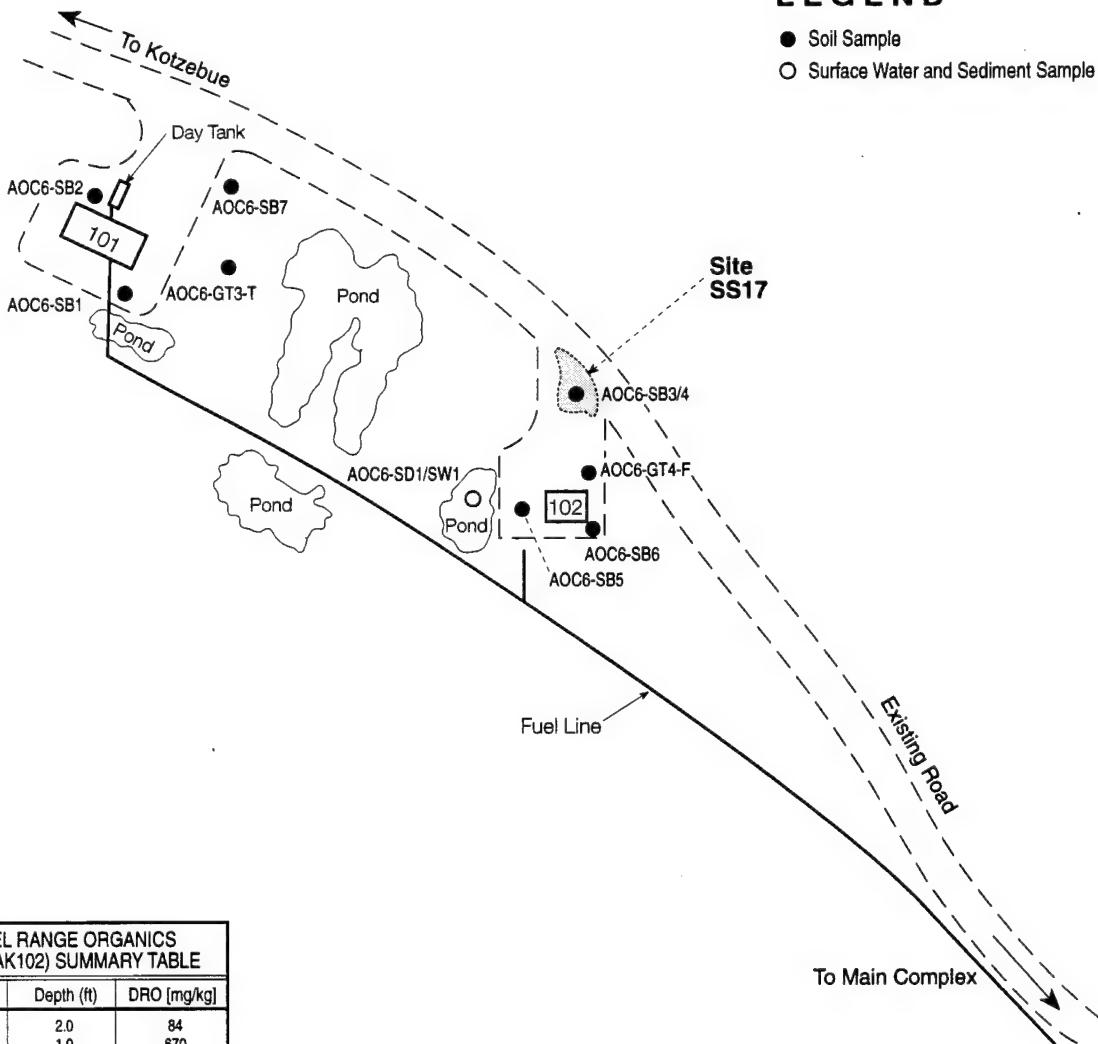
Figure 7. Location of Sample Stations at Site SS17-Building 102 (AOC6), 1994 Remedial Investigation, Kotzebue LRRS, Alaska.

During the 1994 RI, two surface soil samples were collected from within an area of stained soils approximately 6 feet by 12 feet, located at the Navigational Aid Building No. 102 (Figure 7). The samples were screened for PCBs using Dexsil CLOR-N-SOIL™ field test kits. The PCB field test kits provide a colorimetric indication of PCB concentrations equal to or greater than 50 mg/kg in soil. Field screening results detected PCBs in both soil samples collected from the stained soil. Based on these preliminary findings, the USAF formally identified the area of stained soils as Site SS17-Building 102.

During the 1994 RI, a soil sample (AOC6-SB3) was collected from the area of stained soil at Building 102 (see Figure 7). Sample AOC6-SB3 was analyzed for diesel range organics (Method AK102), volatile organic compounds (EPA Method SW 8260), semivolatile organic compounds (EPA Method SW 8270), and pesticide and PCBs (EPA Method SW 8081). No PCBs were detected in Sample AOC6-SB3. It is suspected that the petroleum hydrocarbon contamination found in stained soils interfered with the PCB field test kit, causing false positive results. A summary of maximum detected concentrations identified in the single soil sample collected at Site SS17 is provided below:

State and federal ARARs established to guide the 1994 RI are at least as stringent as those criteria developed during previous IRP investigations at Kotzebue LRRS (see RI/FS Report; USAF 1995a). Petroleum hydrocarbon contamination in gravel fill material is the only environmental concern at the site. Diesel range organics were detected in Sample AOC6-SB3 at 1,500 mg/kg, exceeding the 1,000 mg/kg ADEC soil target level established for Kotzebue LRRS.

Analytical results did not indicate PCBs are present in the stained soil associated with Site SS17. The area of stained soil at Site SS17 is included in the characterization of Site SS16-Navigational Aid Buildings); therefore, no further action is recommended at Site SS17.
